## Safety Recall – 2023 CX-50 Trailer Tow Hitch Harness May Detach

This repair is to remove the old Trailer Hitch Harness and install a new updated harness with a different routing than the original factory, dealer or customer installed harness.

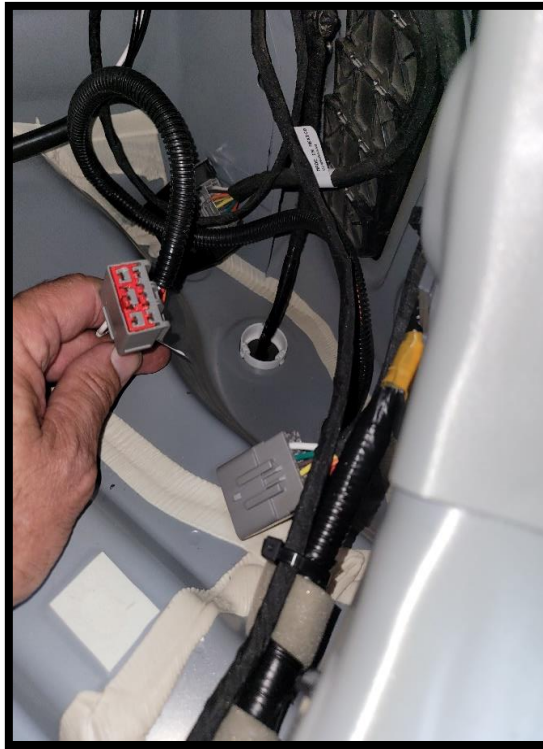
5. Locate the exterior trailer hitch harness and disconnect it.

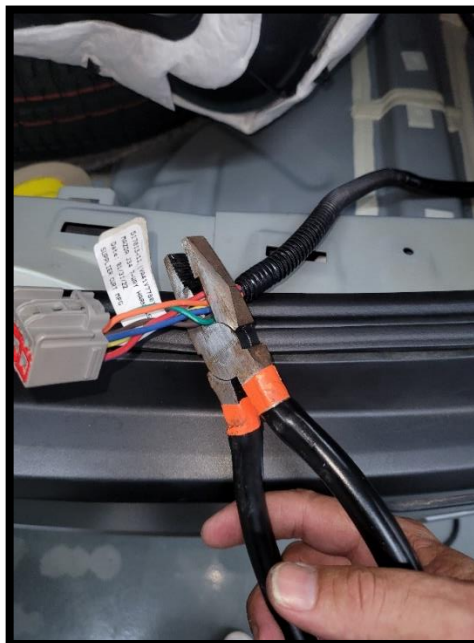
6. Using wire cutters ① cut the exposed wires (female connector) from the exterior harness near the start of the black loom tubing.

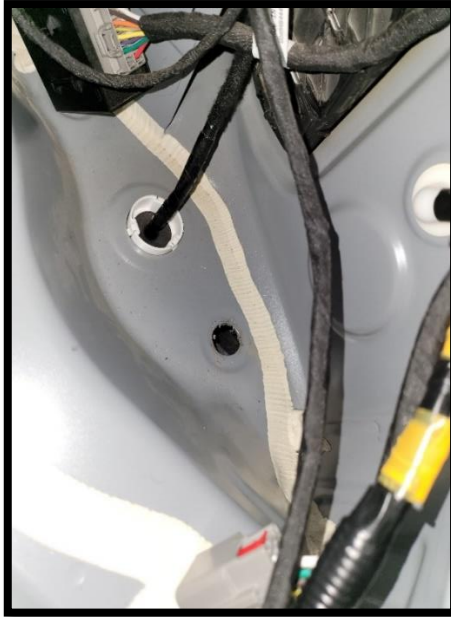
7. Remove harness from interior of vehicle by pushing existing grommet down through the hole and out the bottom of the vehicle.

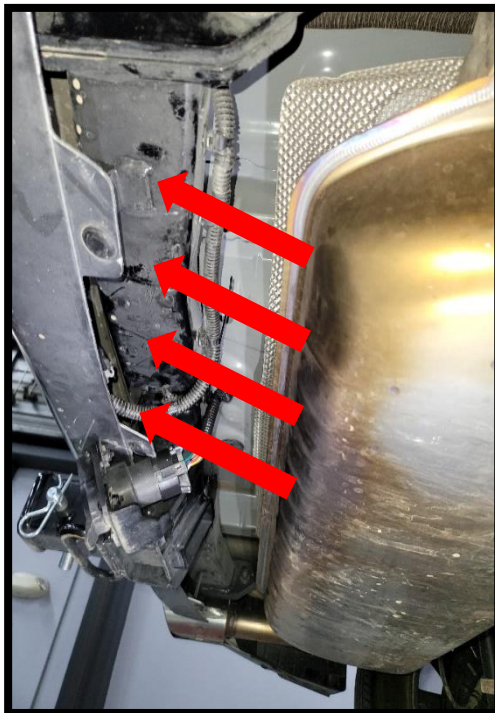
8. Using a fork style panel clip removal tool (2) to remove the harness cable mount clips from tow bar.

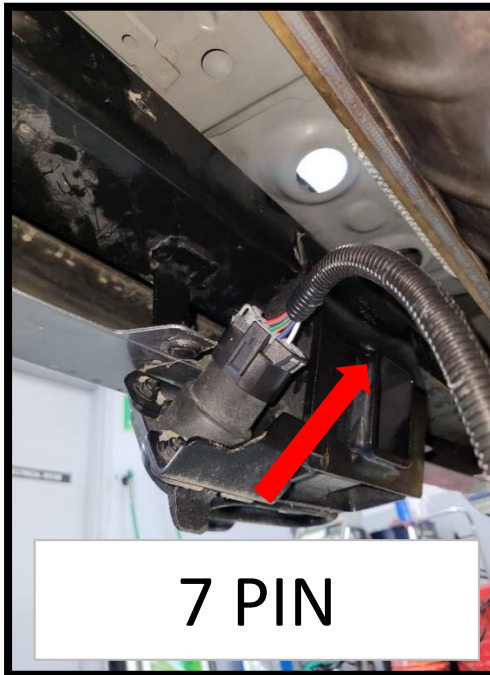
Remove the 7-pin connector from back of 7 pin trailer connector and discard exterior harness.

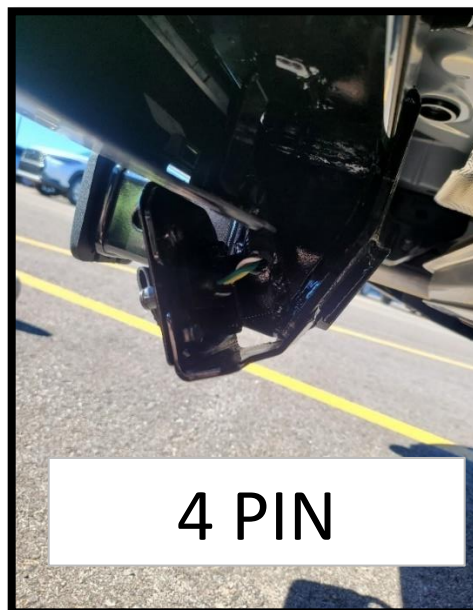
Or remove the 4-pin connector from tow bar bracket and discard exterior harness.

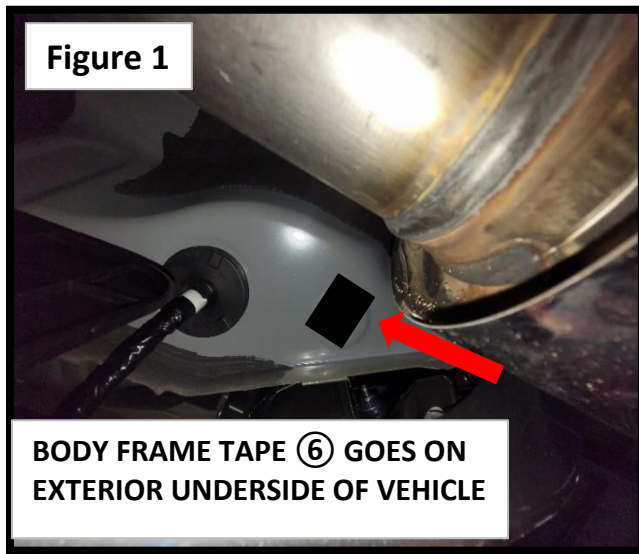
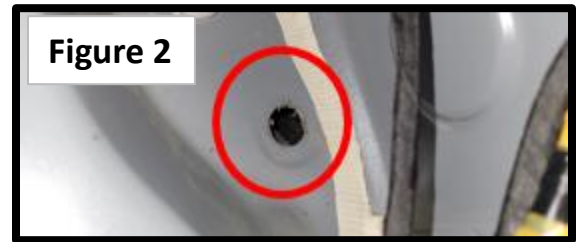
10. Locate the exposed hole where the hitch harness used to go through, under the vehicle near the exhaust.
- Remove any silicone around the hole if present with a plastic scraper tool ③.
  - Using isopropyl alcohol ④ and a shop towel ⑤, thoroughly clean the hole surface area to be covered. Let alcohol dry completely (30 to 60 seconds).
  - Figure 1. Apply body frame tape ⑥ from new harness kit over hole. Press firmly to ensure complete coverage and adhesion. Use 2 pcs if hole is not completely covered.
  - Figure 2. On the inside of the vehicle, apply a silicone-based, anti-corrosion sealer ⑧ to edge of hole from interior side of vehicle.

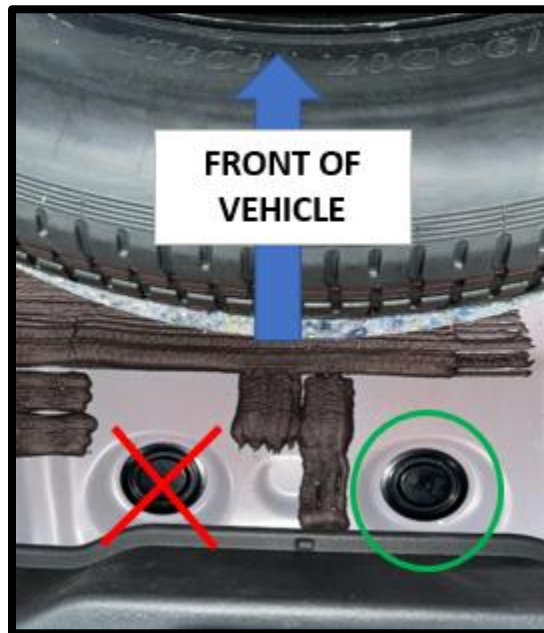
1. Locate the right drain plug in back of the spare tire and remove.

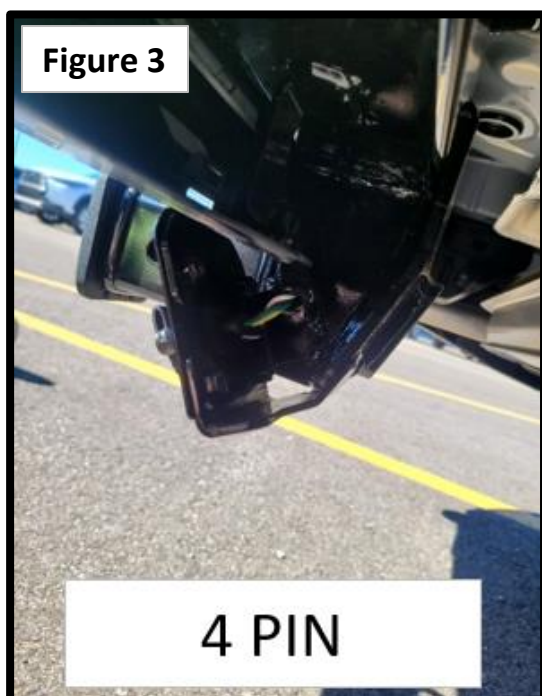
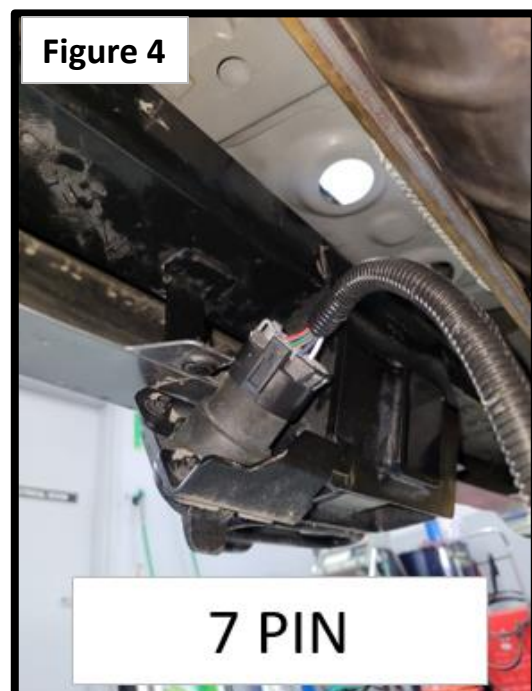
2. Install 4 pin or 7 pin harness connectors.
  - a. Figure 3. Attach 4 pin harness with attachment plate included in main towbar kit with supplied bolts and nuts.
  - b. Figure 4. Plug harness connector into back of connector of 7 pin connector.

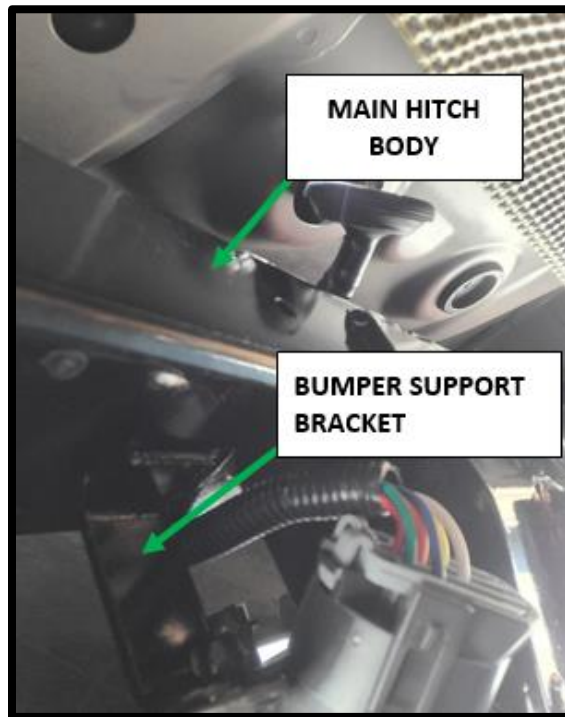
3. Route harness back towards rear of car between main hitch body and bumper support bracket.

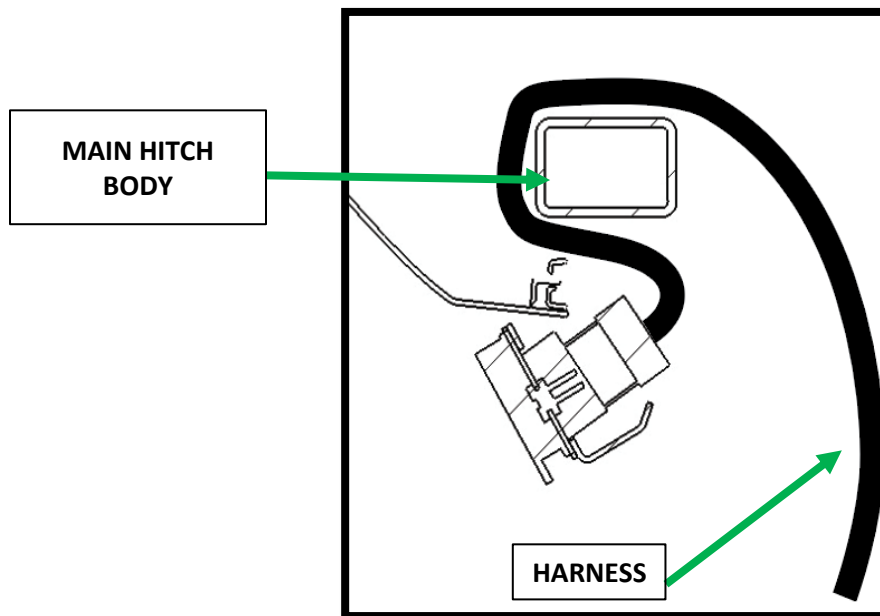
4. Bring harness up and over main bar and back over rear of tow bar.

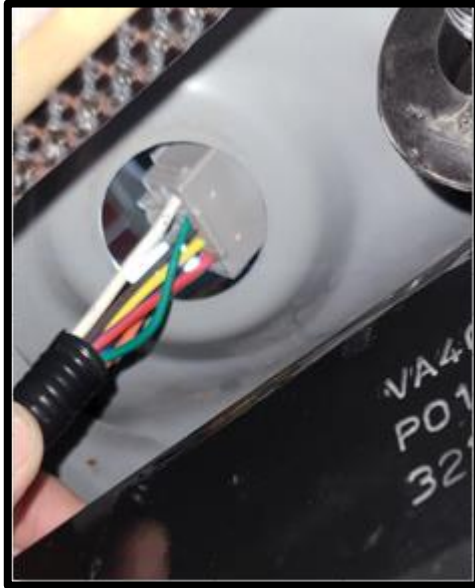
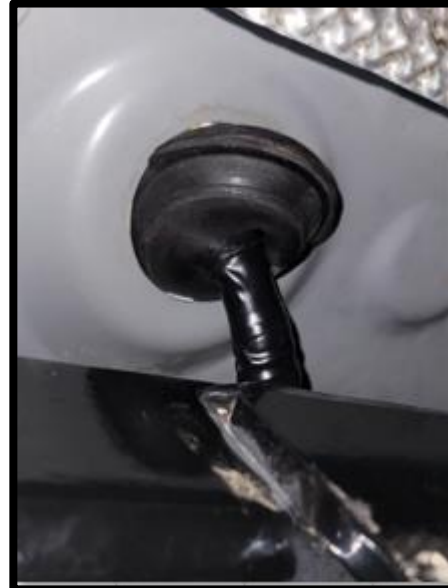
5. Locate the female connector for the new harness. Insert the harness up through drain hole and push grommet attached to new harness through hole.

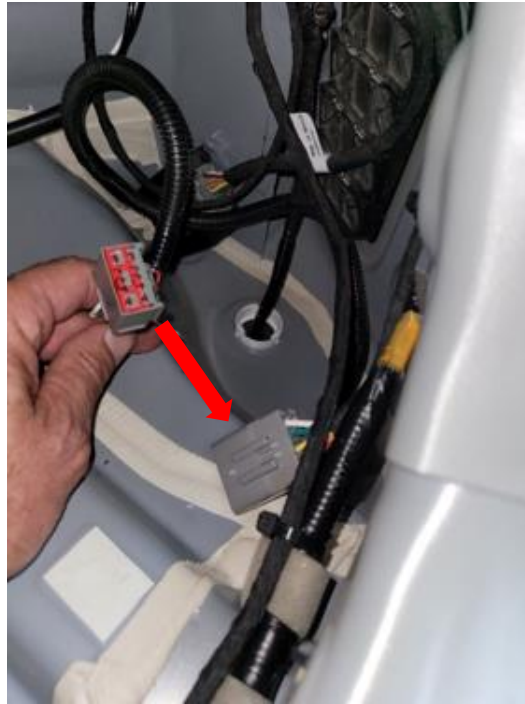
7. Plug exterior harness female connector into interior male harness connector.

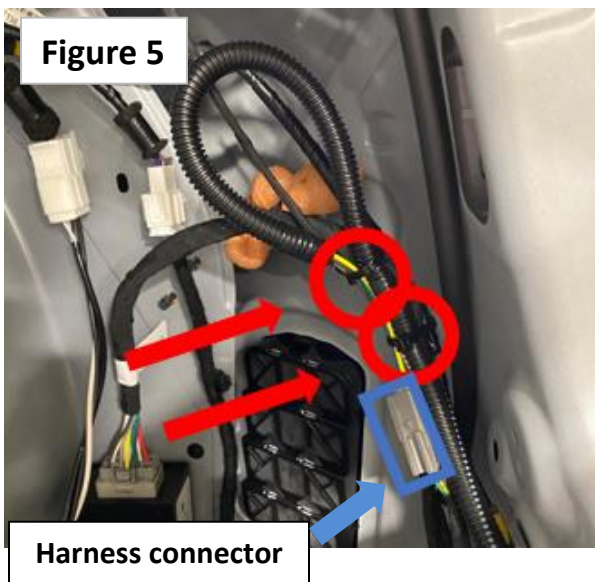
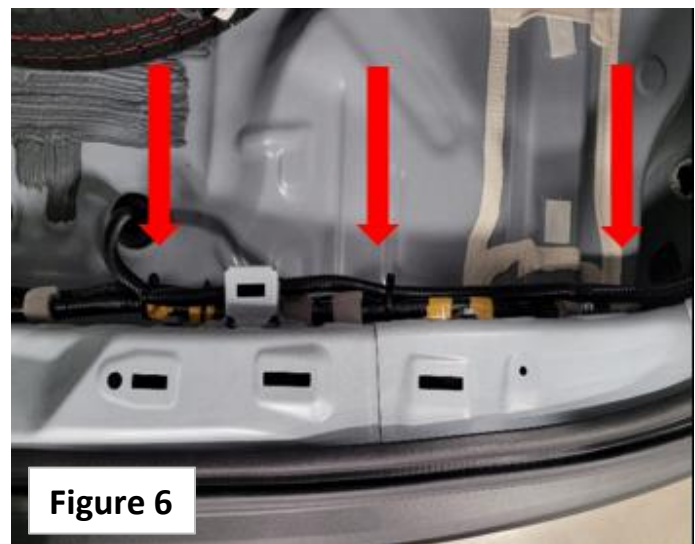
8. Using the 5 supplied zip ties (7) from the repair kit attach to the locations highlighted with red arrows in Figures 5 and 6. Do not overtighten the ties. Make sure the hitch harness connector is securely fastened in Figure 5 (blue arrow and square).

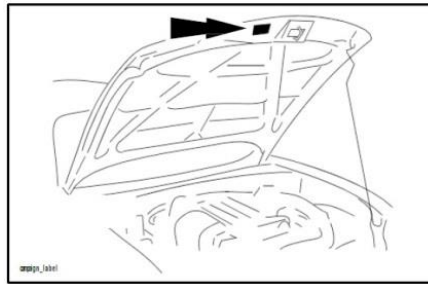
- b. Affix it to the hood as shown:
